Personal Protective Equipment Conformity Assessment Studies and Evaluations

Evaluation of a Self-Contained Breathing Apparatus Involved in a Near Miss While Operating at a Structure Fire

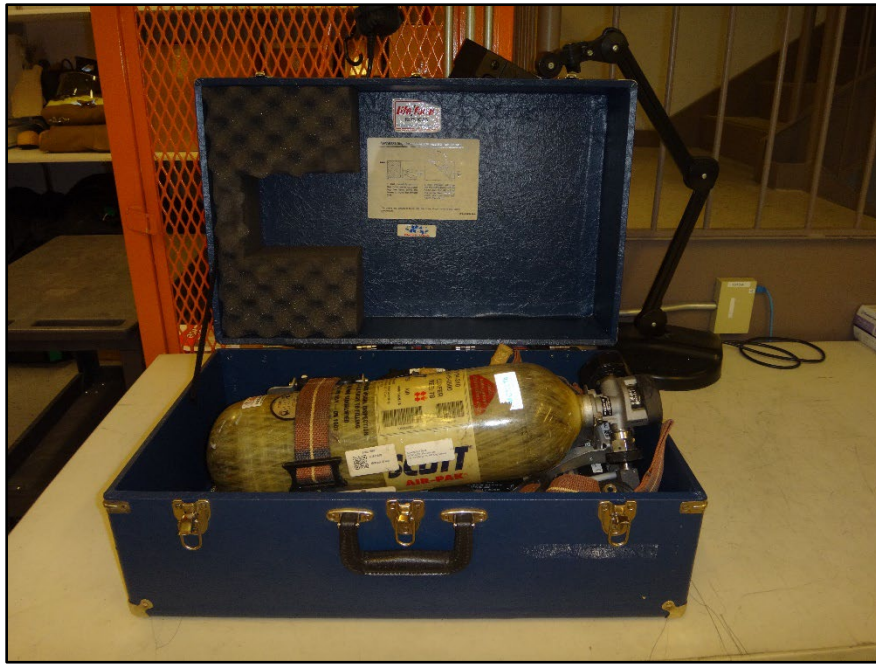
Figure 2: Unboxed SCBA as received
